Steam Turbine Seal Rub

Vibration data helps to identify a steam turbine seal rub.

Sotirios Christofi | Deputy Manager, Head of Mechanical Maintenance, Thessaloniki Refinery | s.c.christofi@helpe.gr

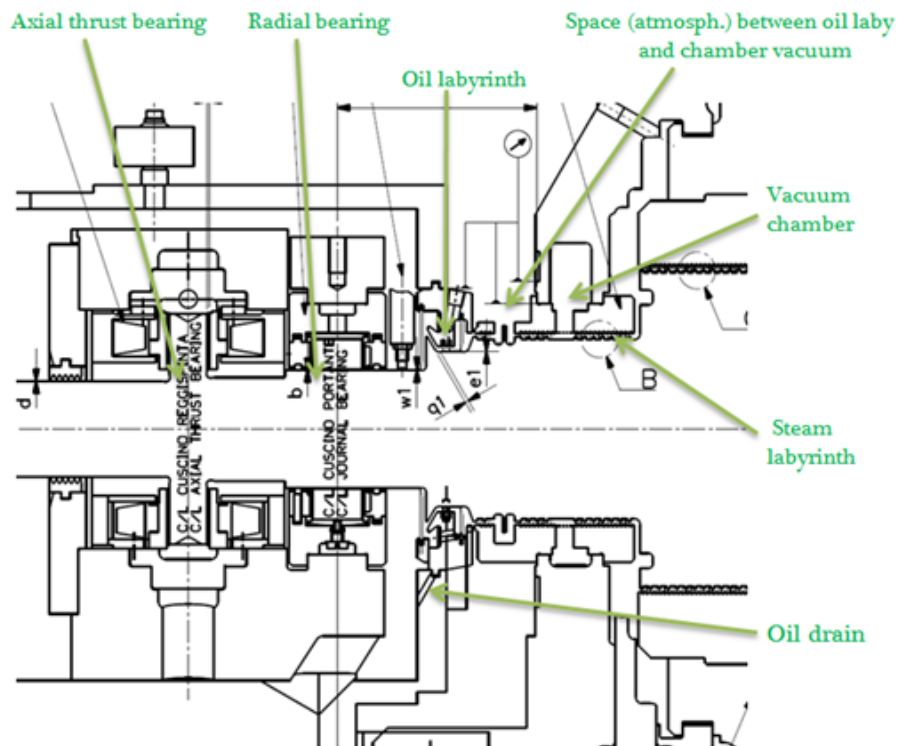
Figure 1: *Turbine cross-section drawing –Non-Drive End*

The drawing in figure 1 shows a cross section of the non-drive end (NDE) of the turbine. The bearing lubrication oil is contained by the oil labyrinth. Any oil leaking past the lip seals of the oil labyrinth normally flows to the drain. Any evaporated oil fumes are evacuated from the space between the oil and steam labyrinth by the vacuum separation system.

The vacuum chamber therefore collects flow suction from two directions: the steam leaking from the steam labyrinth seal and the evaporation, if any, of the oil leaking from the oil labyrinth seal. A similar arrangement exists on the drive end (DE) of the turbine.

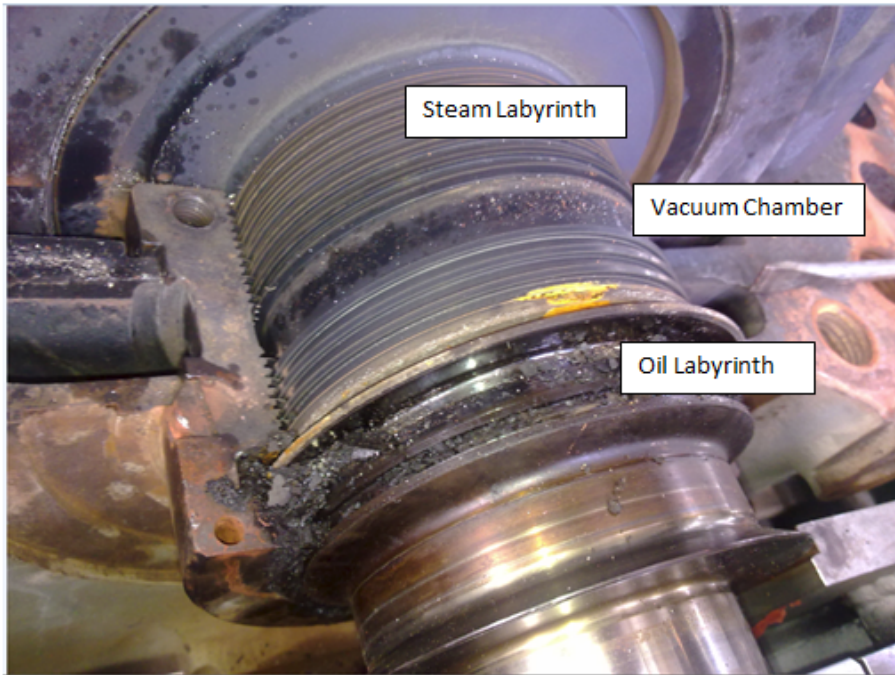
- Unusually high misalignment was found among the turbine bearing supports (offsets of up to 1 mm).
- Carbonized lubricating oil had built up in the seal vacuum chamber and was coming in contact with the turbine rotor (Figure 6).
- One-sided wear of the oil labyrinth rings was discovered (Figure 7).
- No significant damage had occurred to the rotor shaft, steam labyrinths or bearings.

Figure 6: Carbonized oil is visible in the vacuum chamber.

- Misalignment caused uneven wear on one side of the oil labyrinth rings.
- Excess oil leaked into the space between the oil rings and the vacuum chamber.

- The oil vapor mixed with high temperature steam in the vacuum chamber.
- The oil heated until it formed hard, carbonized “coke,” which built up until a rub occurred.
- Within a few minutes, the carbon deposits were abraded away through the rubbing action until the rub disappeared. But the leaking oil would form more coke and the cycle would eventually repeat itself.

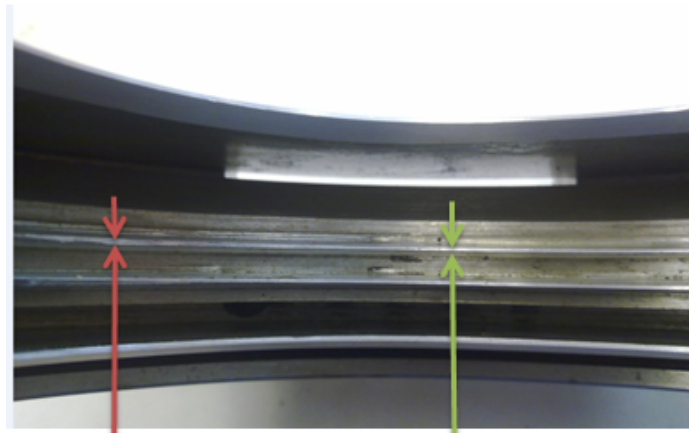
Figure 7: This photo shows uneven (one-sided) wear of oil labyrinth rings
