orbit

VOL. 32 | NO. 4 | OCT 2012

A Technical Publication for
Advancing the Practice of
Operating Asset Condition
Monitoring, Diagnostics, and
Performance Optimization

- 16 Designing and Machining
a Keyphasor* Trigger
- 24 System 1* Software Identifies
Rotor Instability

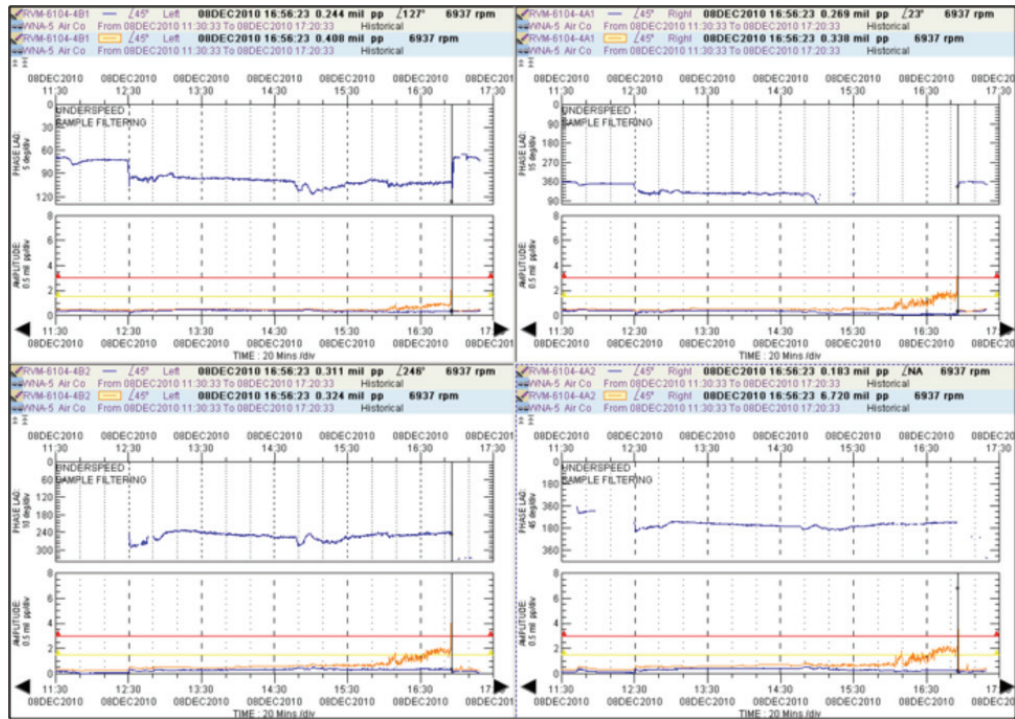
As shown in Figure 3, the rise in "Direct" (unfiltered) amplitude was not caused by an increase in 1X amplitudes.

FIGURE 3: Direct Vibration levels began increasing about an hour before the trip (orange curve in lower half of plots) but no changes were observed in 1X filtered amplitudes (blue curves in upper half of plots). This meant that the increase in amplitude was due to increasing vibration levels at NOT 1X frequencies.

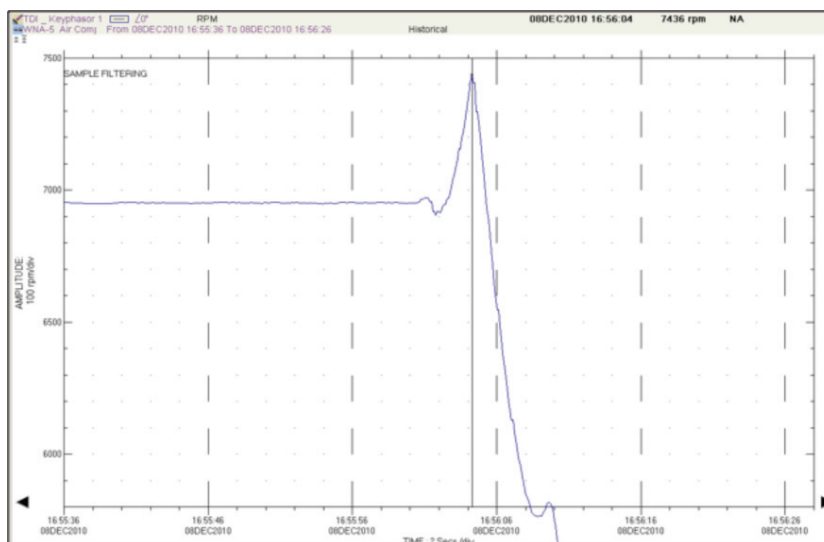
The reason for this behavior can be understood from the trend of turbine speed as shown in Figure 5. At 16:56:01 hours, a small dip in speed was observed and afterward, the speed ramped up from 6950 RPM to 7436 RPM at 16:56:04. This indicates that even though the steam

FIGURE 5: The steam turbine Keyphasor* signal shows that machine speed ramped up from 6950 to 7436 rpm before dropping off during the machine coast-down.

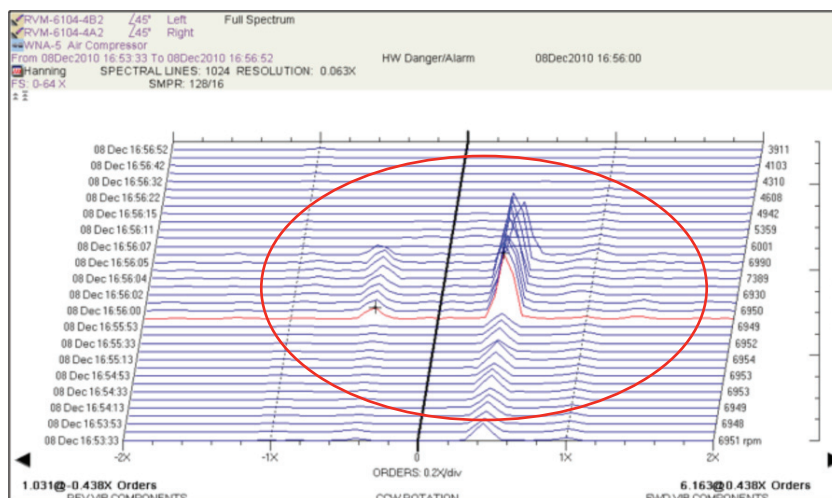
FIGURE 6: Subsynchronous 0.438X frequency that was responsible for increased Direct vibration amplitudes.

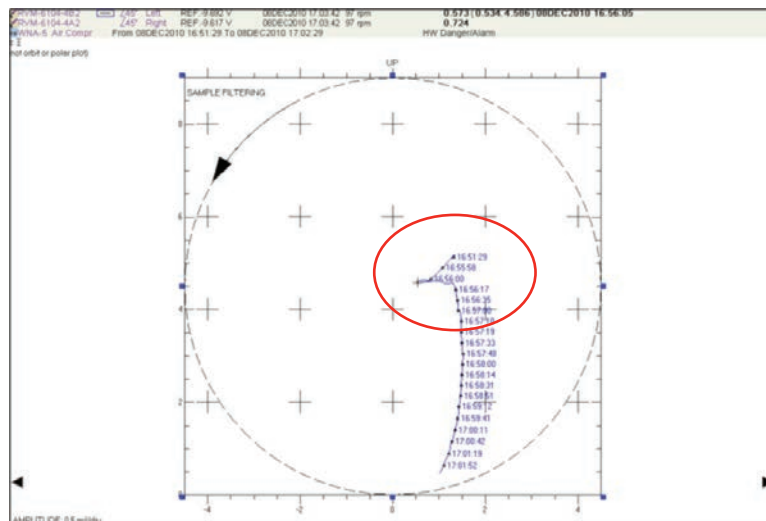
FIGURE 7: Average position of the steam turbine rotor appears to be moving towards a lower eccentricity ratio (closer to the centerline of the bearing bore) at the time of the elevated vibration that led to the trip. From the time of the trip onwards, the shaft centerline position slowly drifts down to the bottom of the bearing clearance – which is a very normal response.

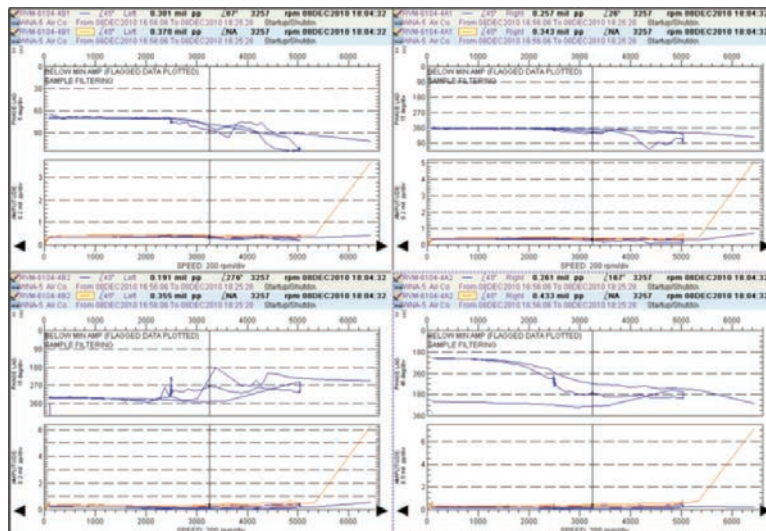
FIGURE 8: Bode plots indicated a natural frequency near 3200 cpm (~53 Hz).

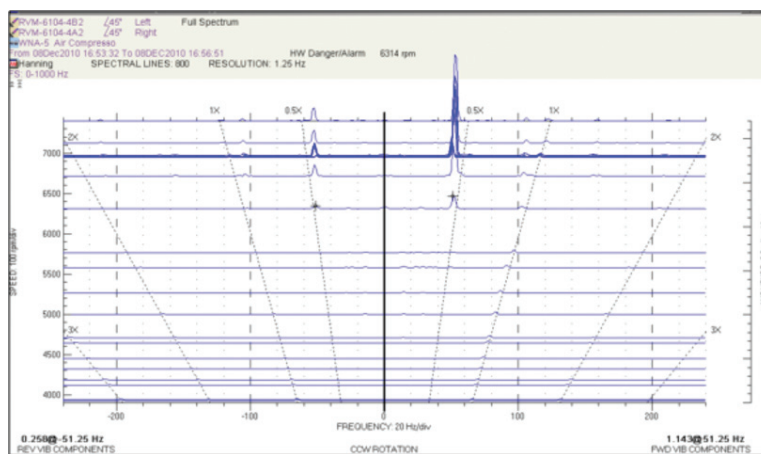
FIGURE 9: Cascade plots for turbine trip and overspeed event. The rotor instability appeared above 6314 RPM at a small amplitude. Then, when the expander came online and unloaded the steam turbine, the instability suddenly became excited at a much higher amplitude. This is also shown in the waterfall plot in Figure 6.

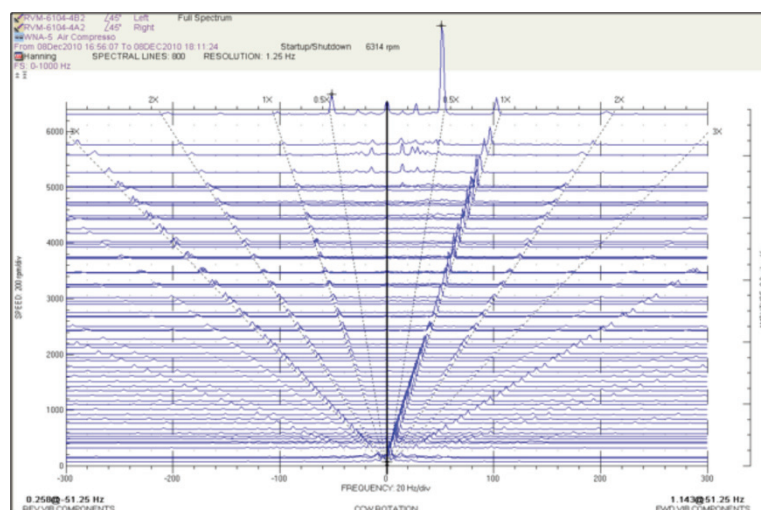
FIGURE 10: The cascade plot for the machine coast-down shows that the subsynchronous vibration components rapidly dissipated as the machine ramped down. It was essentially gone by the time the machine speed slowed to 4000 rpm.

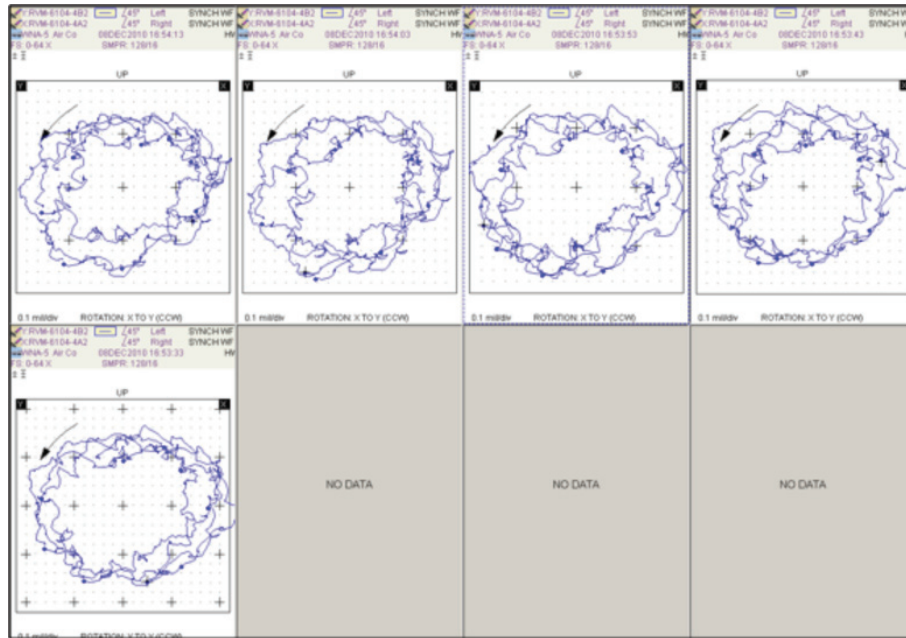
FIGURE 11: These orbit plots show the erratic shaft precession that existed as the whip condition was becoming established (from 16:53:33 to 16:54:13), just a few minutes before the high vibration trip occurred. The data for these plots was collected at 10 second intervals, starting with the plot in the lower row, and then moving from right to left through the plots in the upper row.

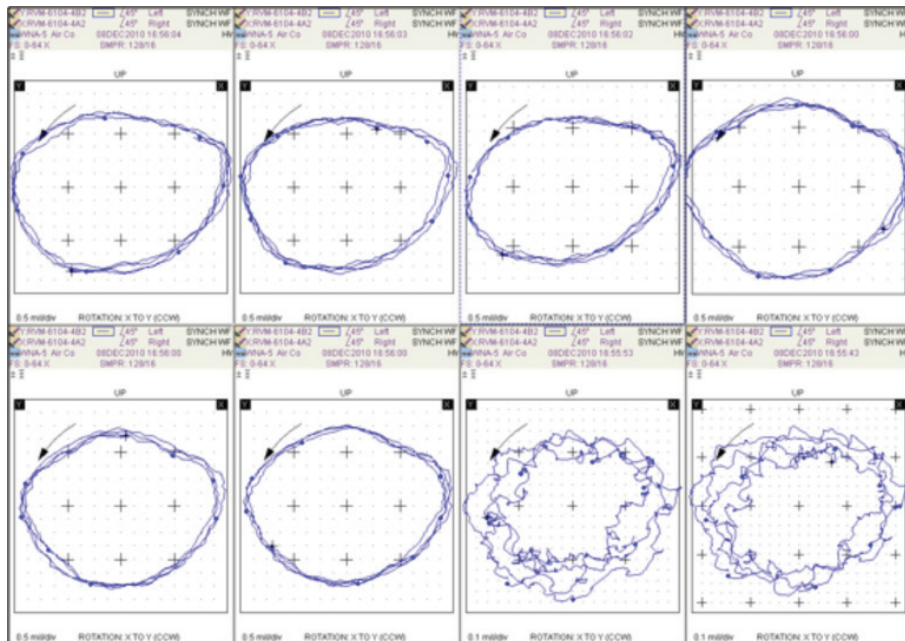
FIGURE 12: These orbit plots show the oil whip symptoms becoming more pronounced from the chaotic motion at 16:55:43 in the lower right corner, through a very circular pattern starting at 16:56:00 (second plot from left in lower row).

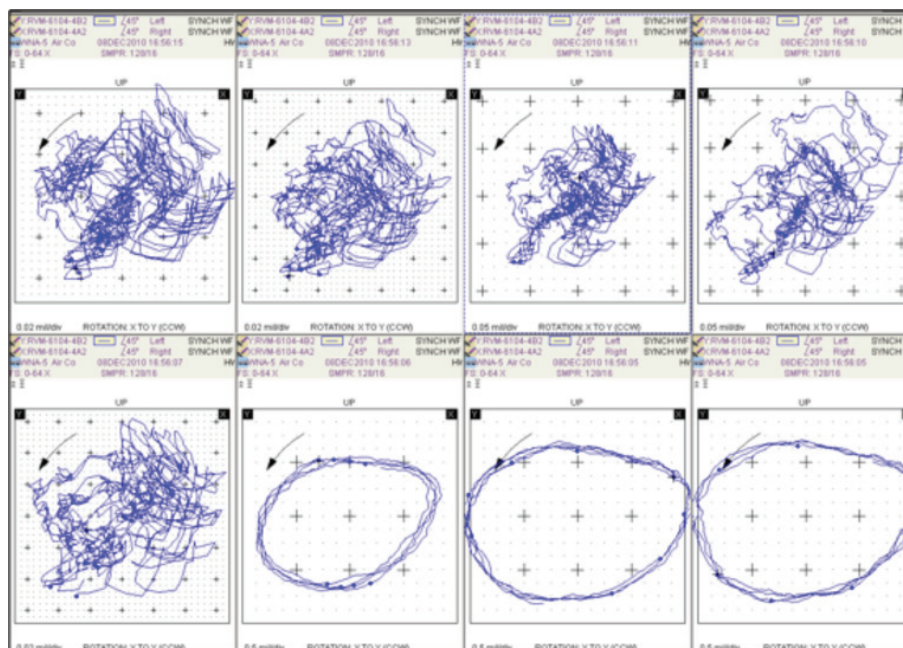
FIGURE 13: These orbit plots show how the shaft centerline movement changed from being very circular during the full whip condition at 16:56:05 (lower right plot), through a period of chaotic movement as the machine coasted down following the trip.

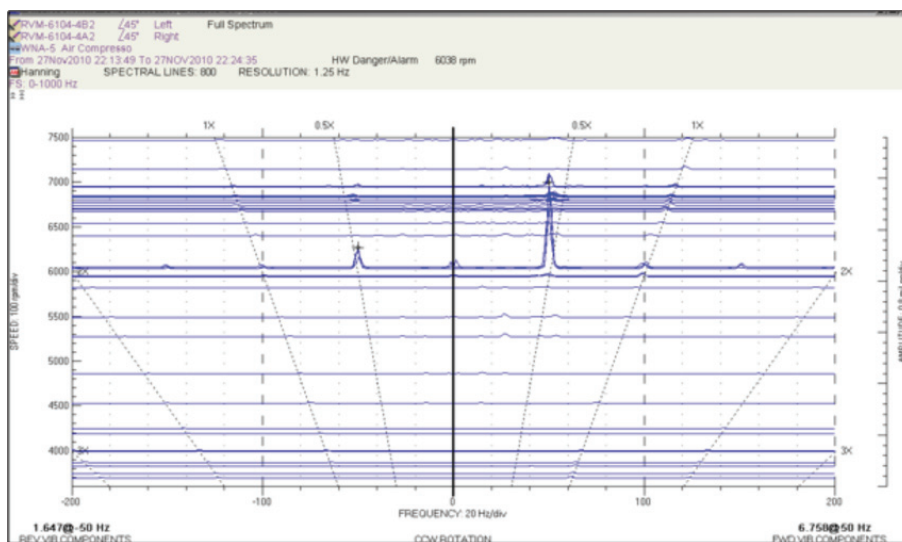
FIGURE 14: For the 27NOV2010 event, the excitation frequency was also about 50 Hz. Observe that a strong forward precession first appeared when reaching 6038 rpm as machine speed increased.

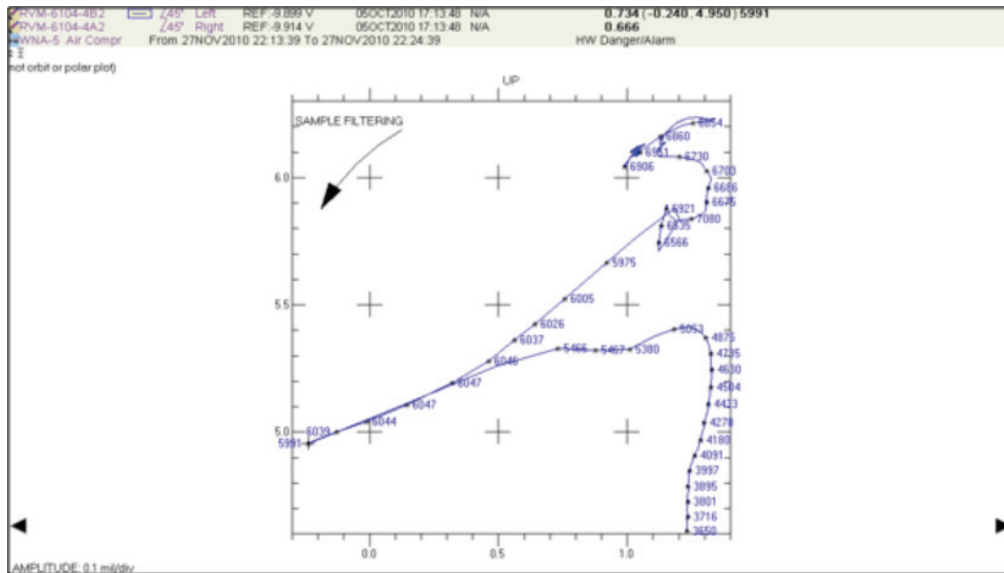
FIGURE 15: Average shaft centerline plot for 27NOV2010, showing the shaft approaching the bearing centerline as the steam turbine became unloaded when the expander came online. Observe the similarity of this plot to Figures 7 and 16, which show the 08DEC2010 event.

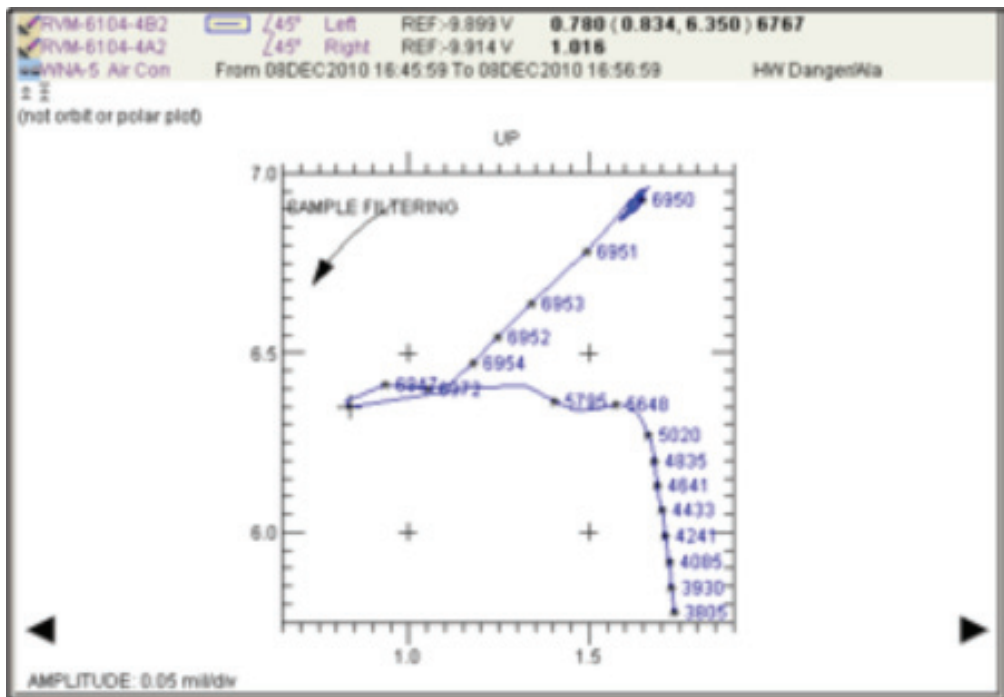
FIGURE 16: Observe the behavioral similarity in average shaft centerline plots between this example from 08DEC2010, and Figure 15, from 27NOV2010. In both cases, the steam turbine rotor moved towards the centerline of its bearing.

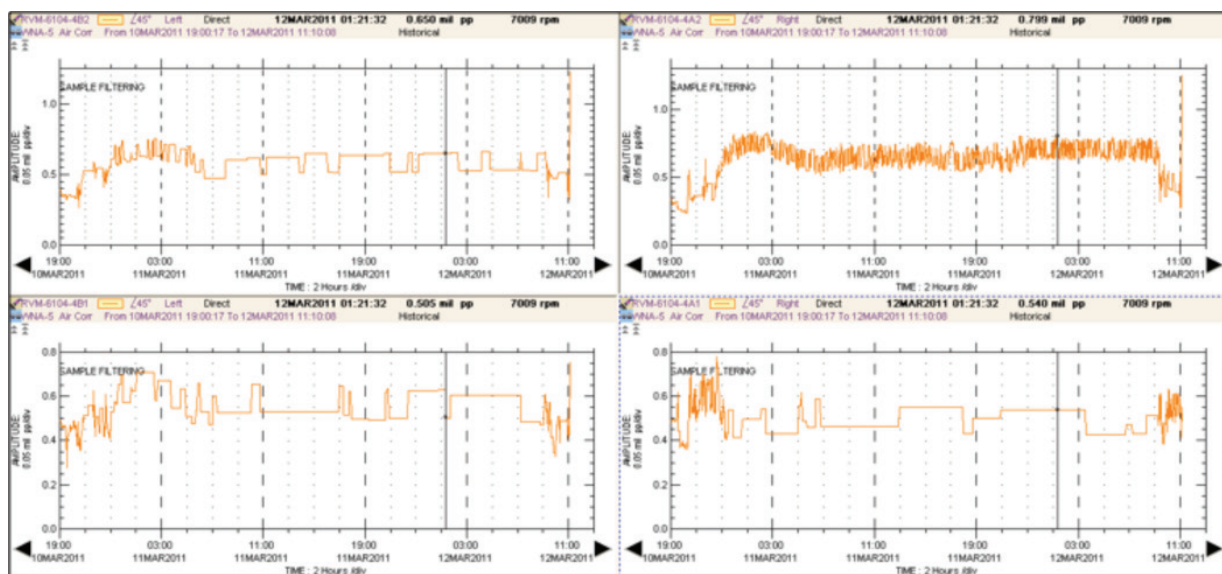
FIGURE 19: Vibration amplitude trends remained within acceptable limits after the bearing design changes were implemented.

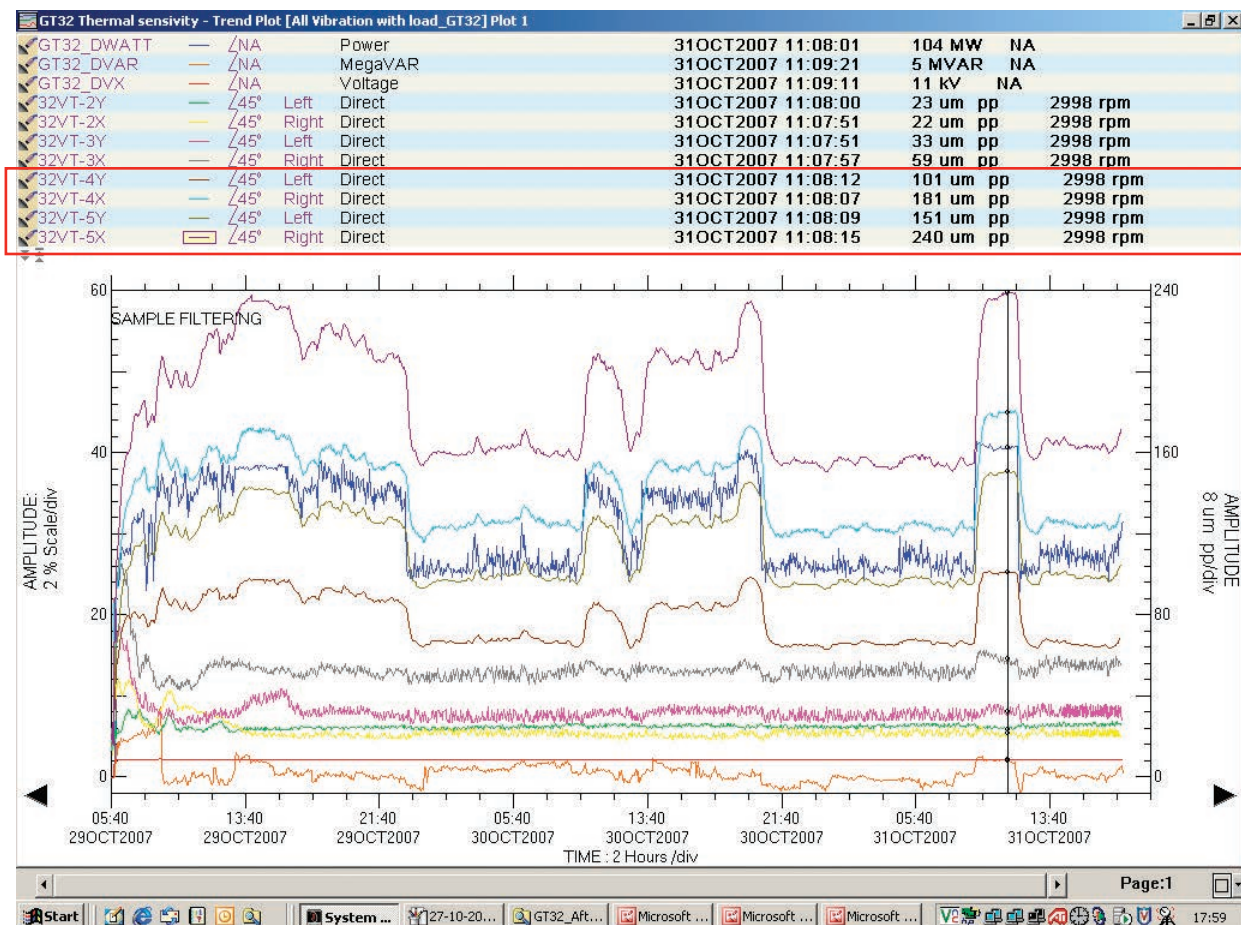
FIGURE 1: Symptoms of a thermally-sensitive rotor were observed during plant startup. The bold blue curve represents generator load, which varied between about 25% and 40% of full load. Most of the remaining curves represent vibration amplitudes, measured as relative displacement of the rotor within its bearings. Observe that these vibration amplitude curves have shapes that are closely match the load profile. The numerical values for the measured parameters correspond to data collected at the time where the trend plot cursor is located near the right end of the plot (31OCT2007, at 11:08).

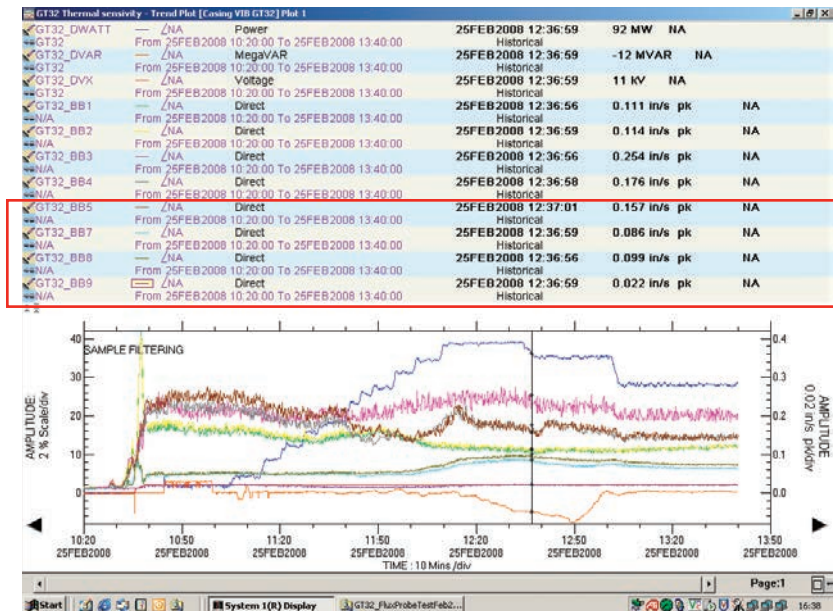
FIGURE 2: Seismic vibration amplitude trends from generator bearing caps, before partial rewinding repair. The bold blue “stair-step” curve represents generator load. Most of the remaining curves represent vibration amplitudes, measured as absolute velocity at the surface of the bearing housings where the seismic sensors are installed. Observe that these vibration amplitude curves do not appear to have any apparent correlation with the load profile.

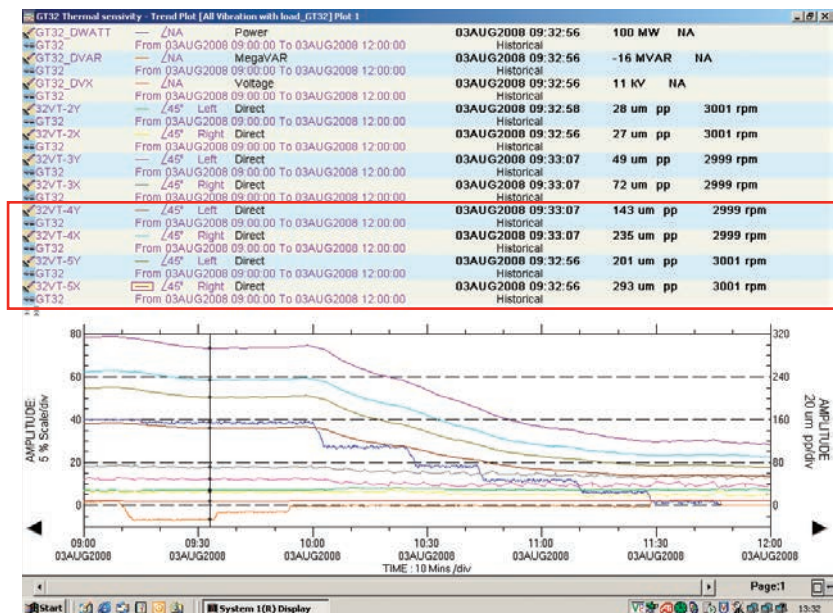
FIGURE 3: Thermal sensitivity test before partial rewinding repair. Generator load was reduced in step intervals (again shown by the bold blue curve) about once every 20 minutes, and vibration amplitudes fell accordingly (as measured by the eddy current proximity transducers).

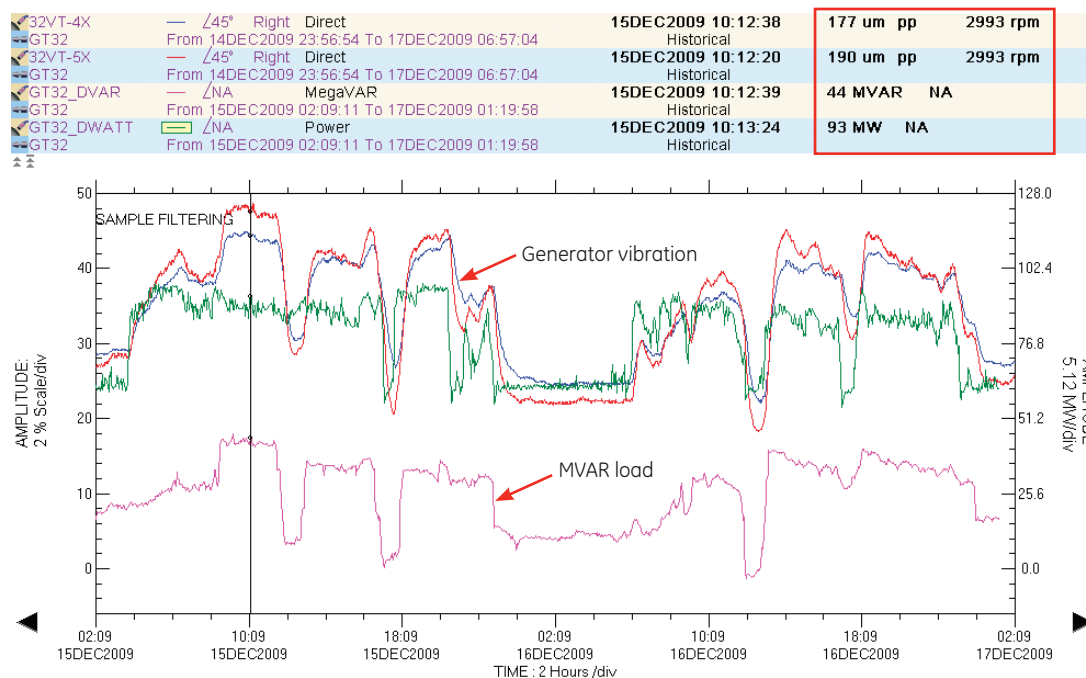
FIGURE 5: Generator vibration amplitude versus time after partial rewinding repair. This trend plot shows a time period of two days, with load profile showing typical variation for a non-base-loaded generation unit.

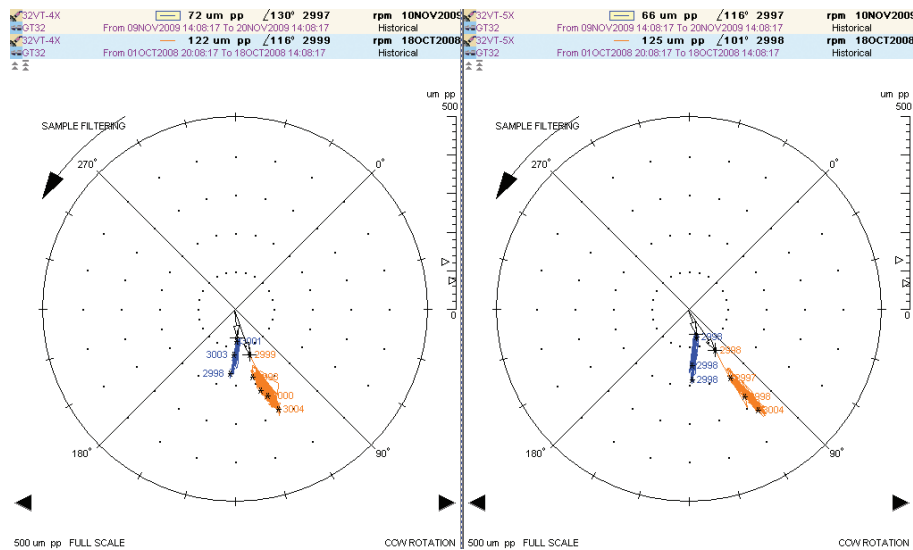
FIGURE 6: Polar plots showing generator rotor thermal vector before (orange data) and after (blue data) partial rewinding repair. Following the repair, vibration amplitudes were about half of the pre-repair values. Also, although the phase angle shifted about 30 to 35 degrees, it was still in-phase from one end of the generator to the other. The left plot shows data from bearing #4 (DE), and the right plot is from bearing #5 (NDE).

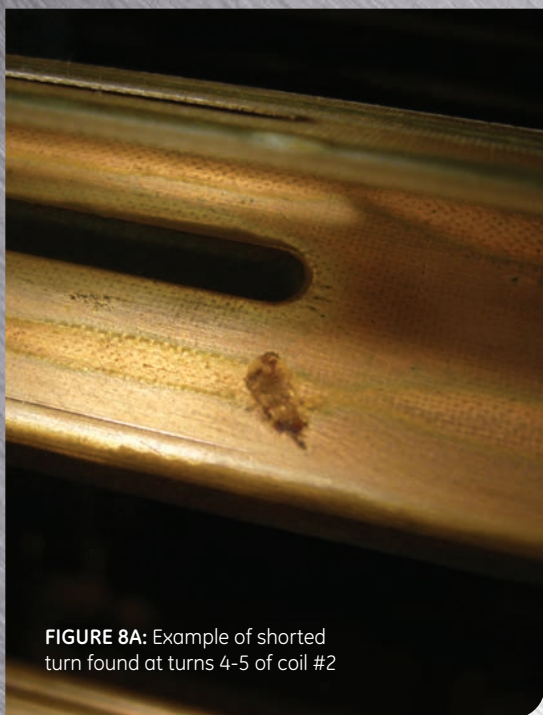
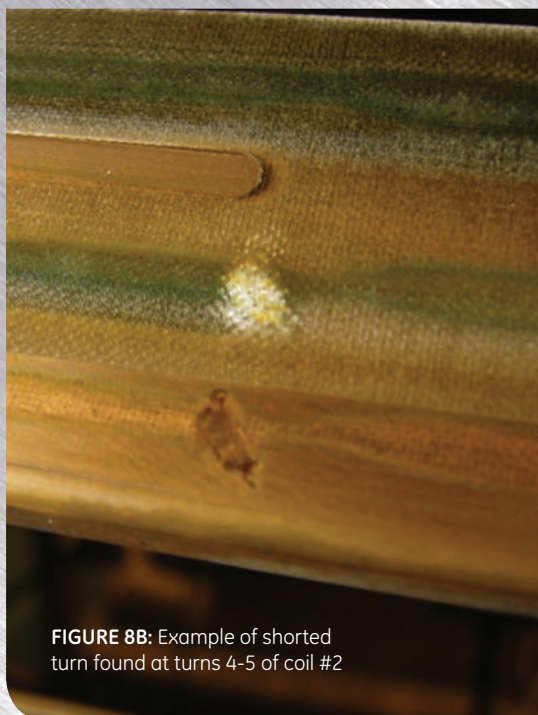
FIGURE 8A: Example of shorted turn found at turns 4-5 of coil #2

FIGURE 8B: Example of shorted turn found at turns 4-5 of coil #2

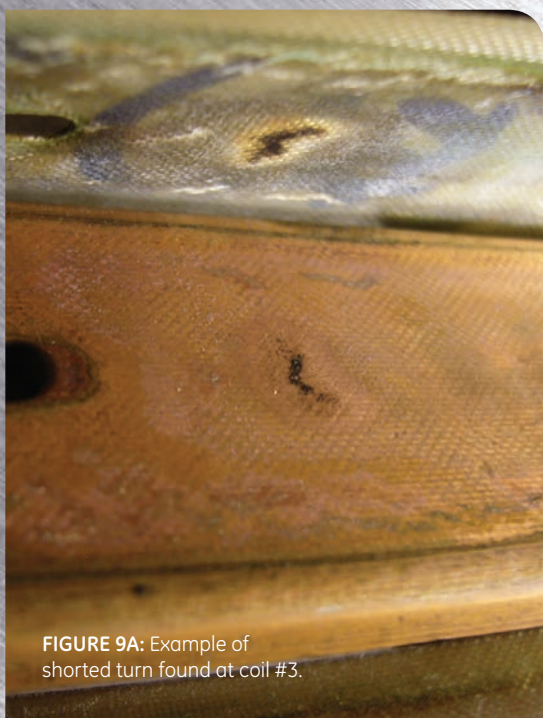
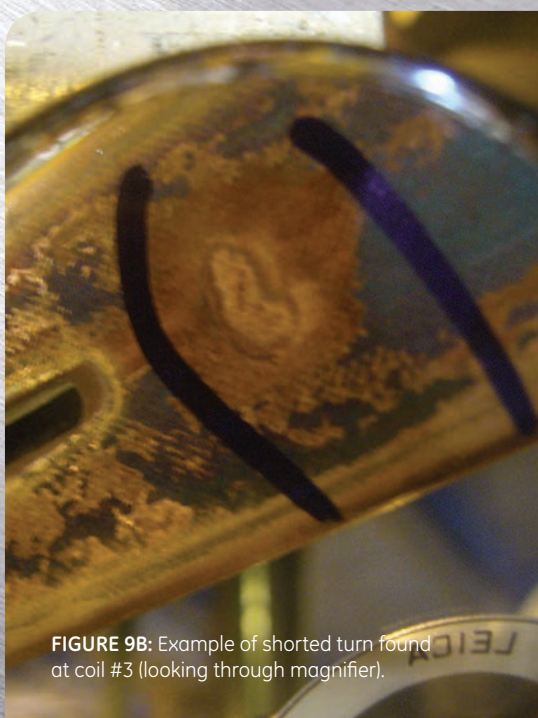
FIGURE 9A: Example of shorted turn found at coil #3.

FIGURE 9B: Example of shorted turn found at coil #3 (looking through magnifier).
