orbit

VOL. 32 | NO. 1 | JAN. 2012

A Technical Publication for
Advancing the Practice of
Operating Asset Condition
Monitoring, Diagnostics, and
Performance Optimization

APPLICATION: One size **does not** fit all

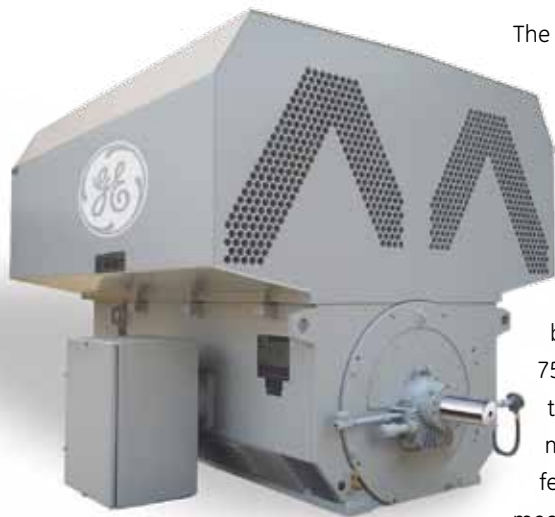
FIGURE 1: GE Pegasus** MHV Medium Voltage AC Induction Motor [Reference 1]

Many of our customers employ medium and large AC motors (such as the representative example in Figure 1) as prime movers for their process machinery, driving large compressors, pumps, blowers and fans. Traditionally, many of these motors have been mechanically protected and managed using Bently Nevada 3500 vibration and condition monitoring systems. The majority of motors in this class employ fluid film bearings.

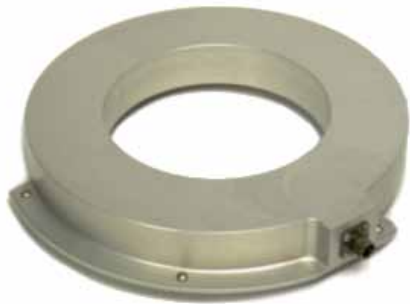
FIGURE 3: The HSCT is a special current transformer that is very sensitive to small values of differential current.

The HSCT (Figure 3) enables measurement of very low amplitude leakage current (which leaks through degraded winding insulation).

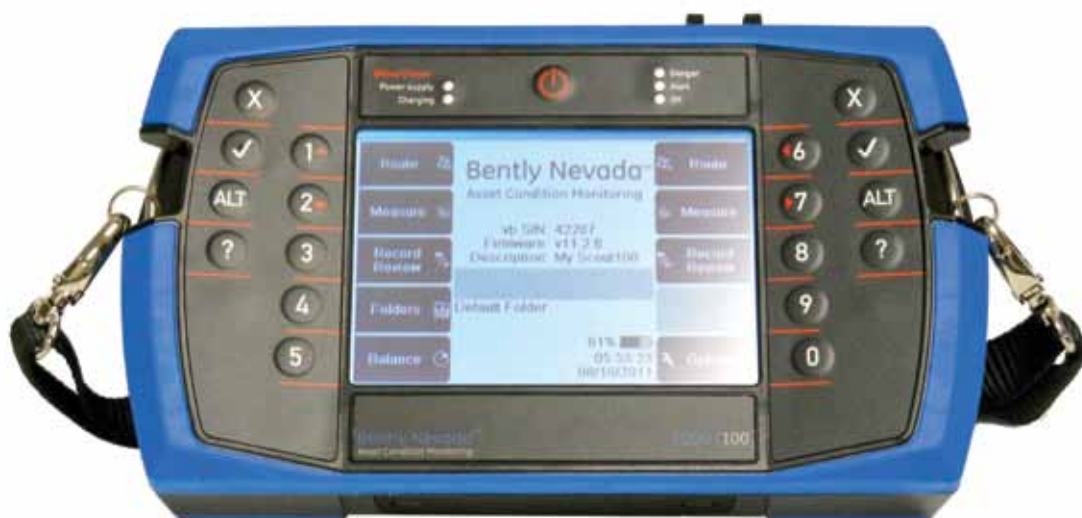
FIGURE 1: Bently Nevada* SCOUT100 Portable Vibration Analyzer

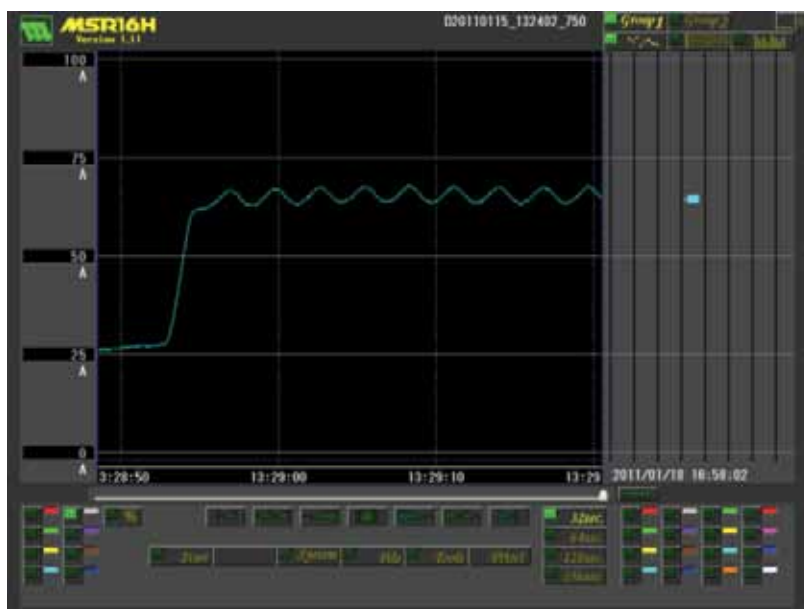
FIGURE 3: Motor Current Trend Plot of the B Motor. Observe that the frequency of the current fluctuation is approximately 0.35 Hz (3.5 cycles/10 seconds).

This plot was created from online measurements made by the portable test device during electrical troubleshooting before the AnomAlert monitor was installed. The portable device does not have a spectrum analysis function, so Mitsui could not perform the frequency analysis needed to identify the source of the observed current fluctuation

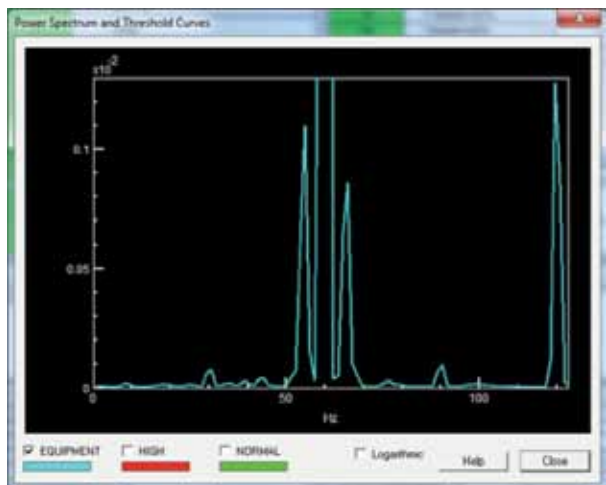
FIGURE 6: PSD plot zoomed around pole pass frequency.

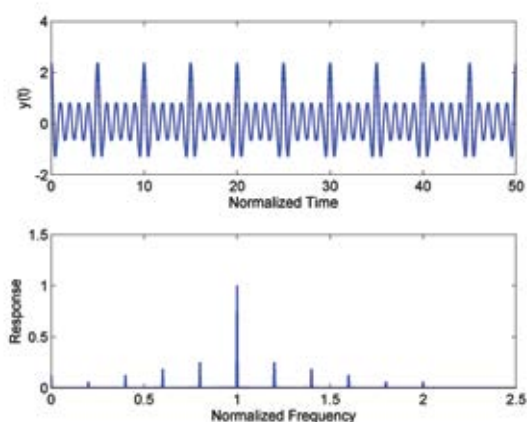
FIGURE 3: Timebase waveform and spectrum plots for a carrier wave modulated by a function having more than one frequency component.

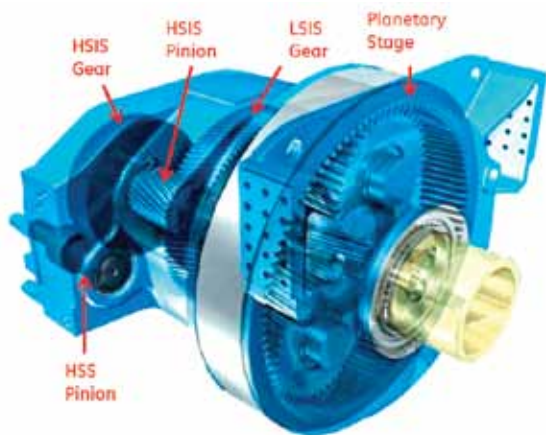
FIGURE 4: Wind turbine planetary gearbox design

Several cases of gear damage were documented by borescope inspections on 1.5MW-class wind turbine generator gearboxes (Figure 4). During the inspections, damage to gear teeth on the high speed intermediate stage shaft (HSIS) pinion was discovered and photographed. The gearboxes with this documented damage were then outfitted with accelerometers and data was collected and analyzed using the Bently Nevada ADAPT.wind monitoring system. The two case studies that follow illustrate successful detection of the known gear damage by the SER algorithm.

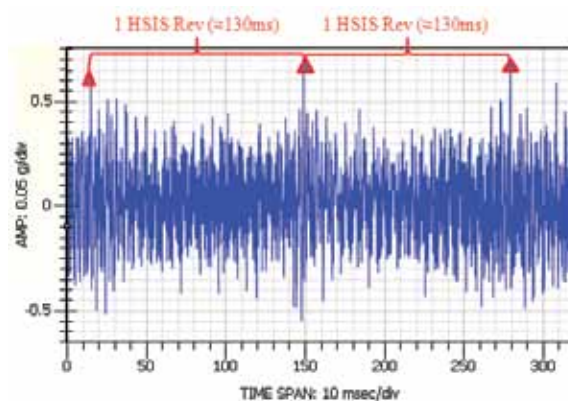
FIGURE 7: Timebase waveform showing amplitude spikes once per revolution of HSIS shaft.

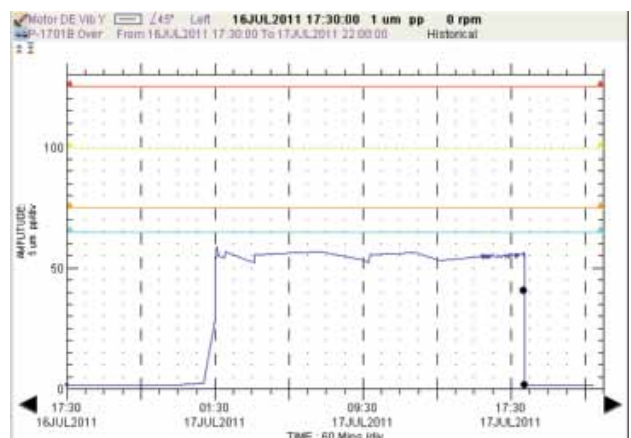
FIGURE 7: Normal vibration amplitudes observed at the DE Y probe after remedial work.
