orbit

VOL. 33 | NO. 3 | JUL 2013

A Technical Publication for
Advancing the Practice of
Operating Asset Condition
Monitoring, Diagnostics, and
Performance Optimization

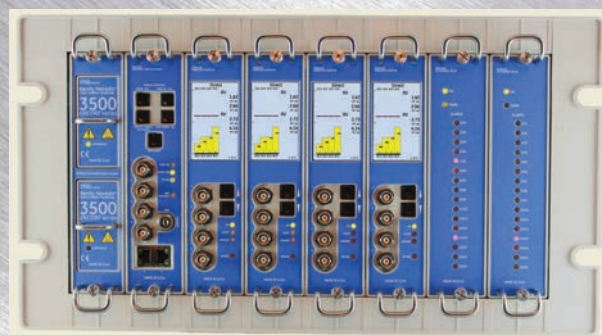
THE 3500 ENCORE SYSTEM: Available in an 8 Position rack – as shown here – or as 10, 12 and 14 Position racks that match legacy 3300 rack sizes.

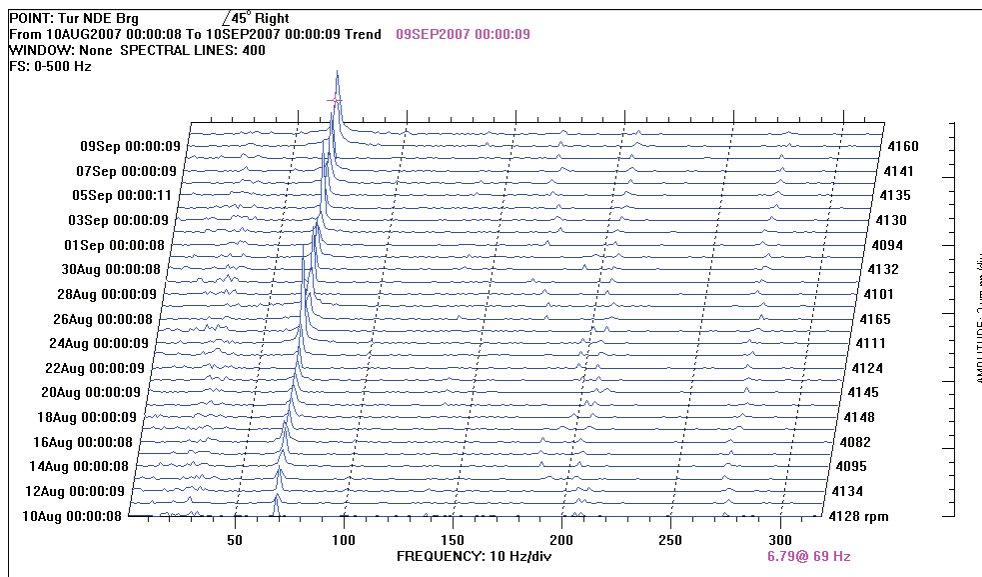
FIGURE 3: August-September 2007 waterfall plot showing spectral components of the vibration excursions on turbine NDE bearing during August and September. Note: The ~69 Hz peak corresponds to the machine running speed, which validates that it is 1X vibration.

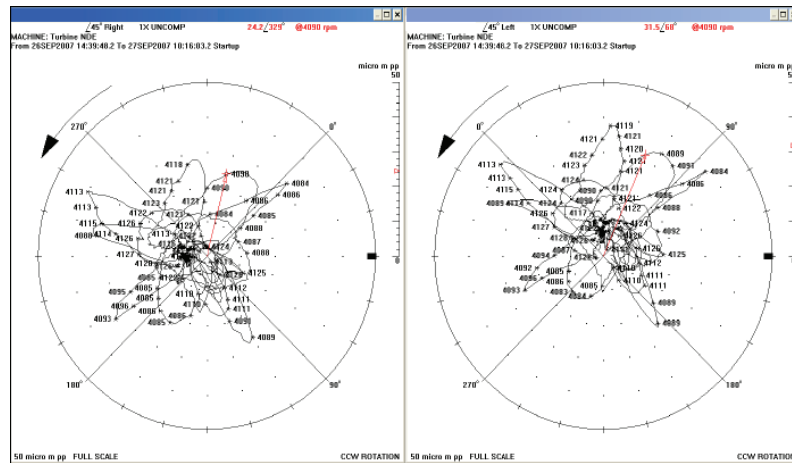
FIGURE 4: September 2007 ADRE polar plots showing widely varying phase angles for different high vibration events.

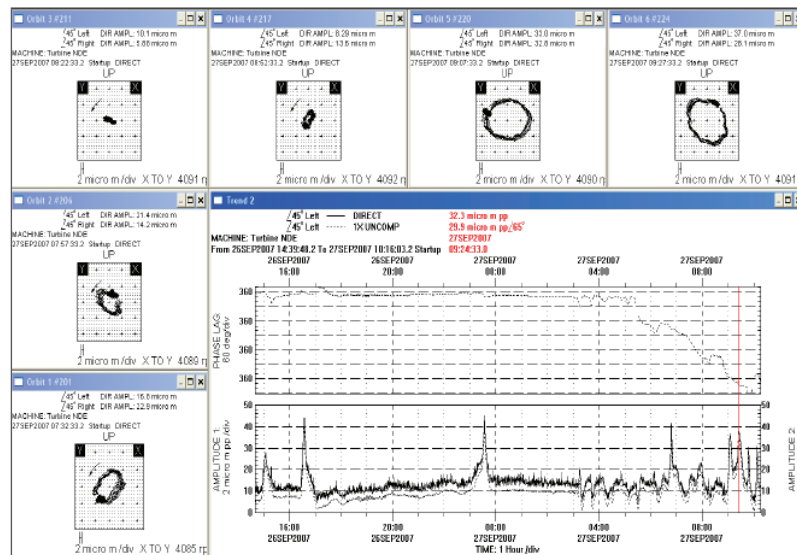
FIGURE 5: September 2007: ADRE plots show changes in orbit size and vibration phase (Keyphasor dot) indicating intermittent rotor bow symptoms.

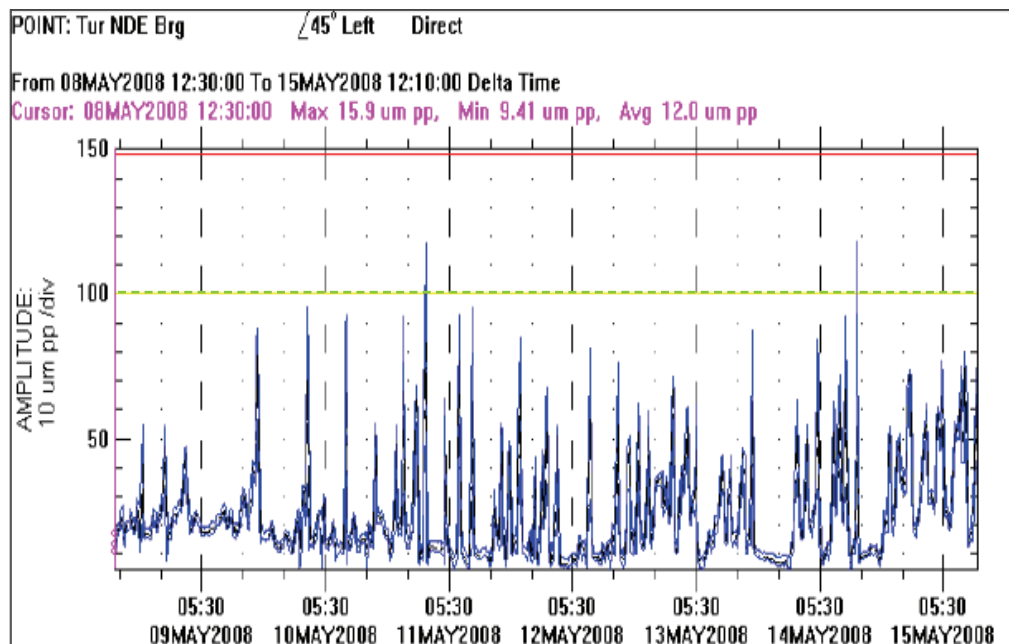
FIGURE 7: May 2008 trend shows persisting vibration excursions, occasionally crossing the Alert set point (yellow line, emphasized by a dashed line overlay at 100 microns pp).

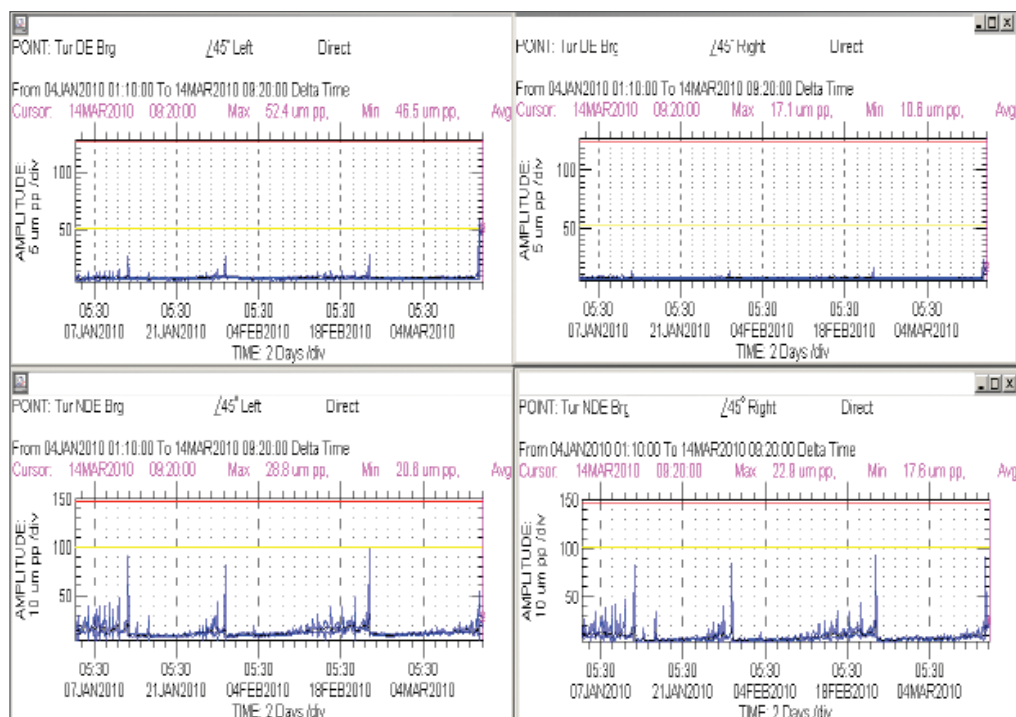
FIGURE 8: January-March 2010 trends show that vibration excursions continued, and that the period between episodes of peak amplitude was increasing.

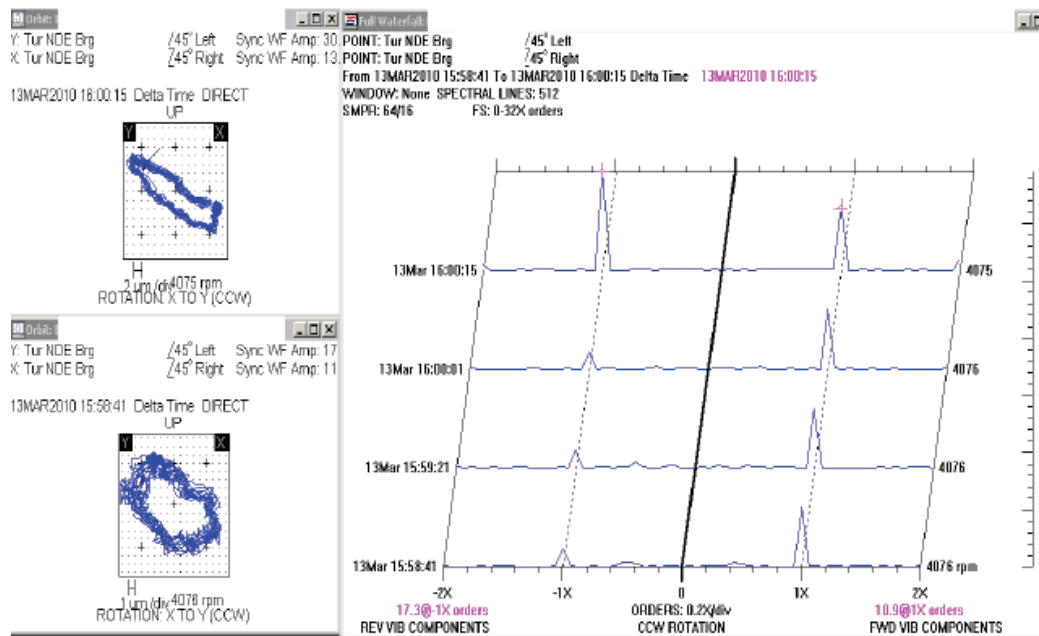
FIGURE 10: Orbits and full waterfall for steam turbine NDE bearing. Reverse 1X frequency components dominated, and change in orbit shape indicated a change in radial loading caused by the increase in rub severity.

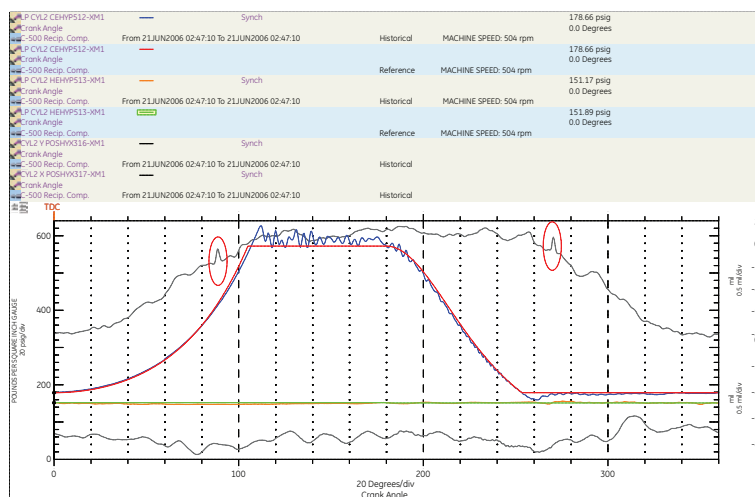
FIGURE 7: The vertical piston rod vibration signal (top grey line) shows two spikes that are symmetrical with respect to BDC.

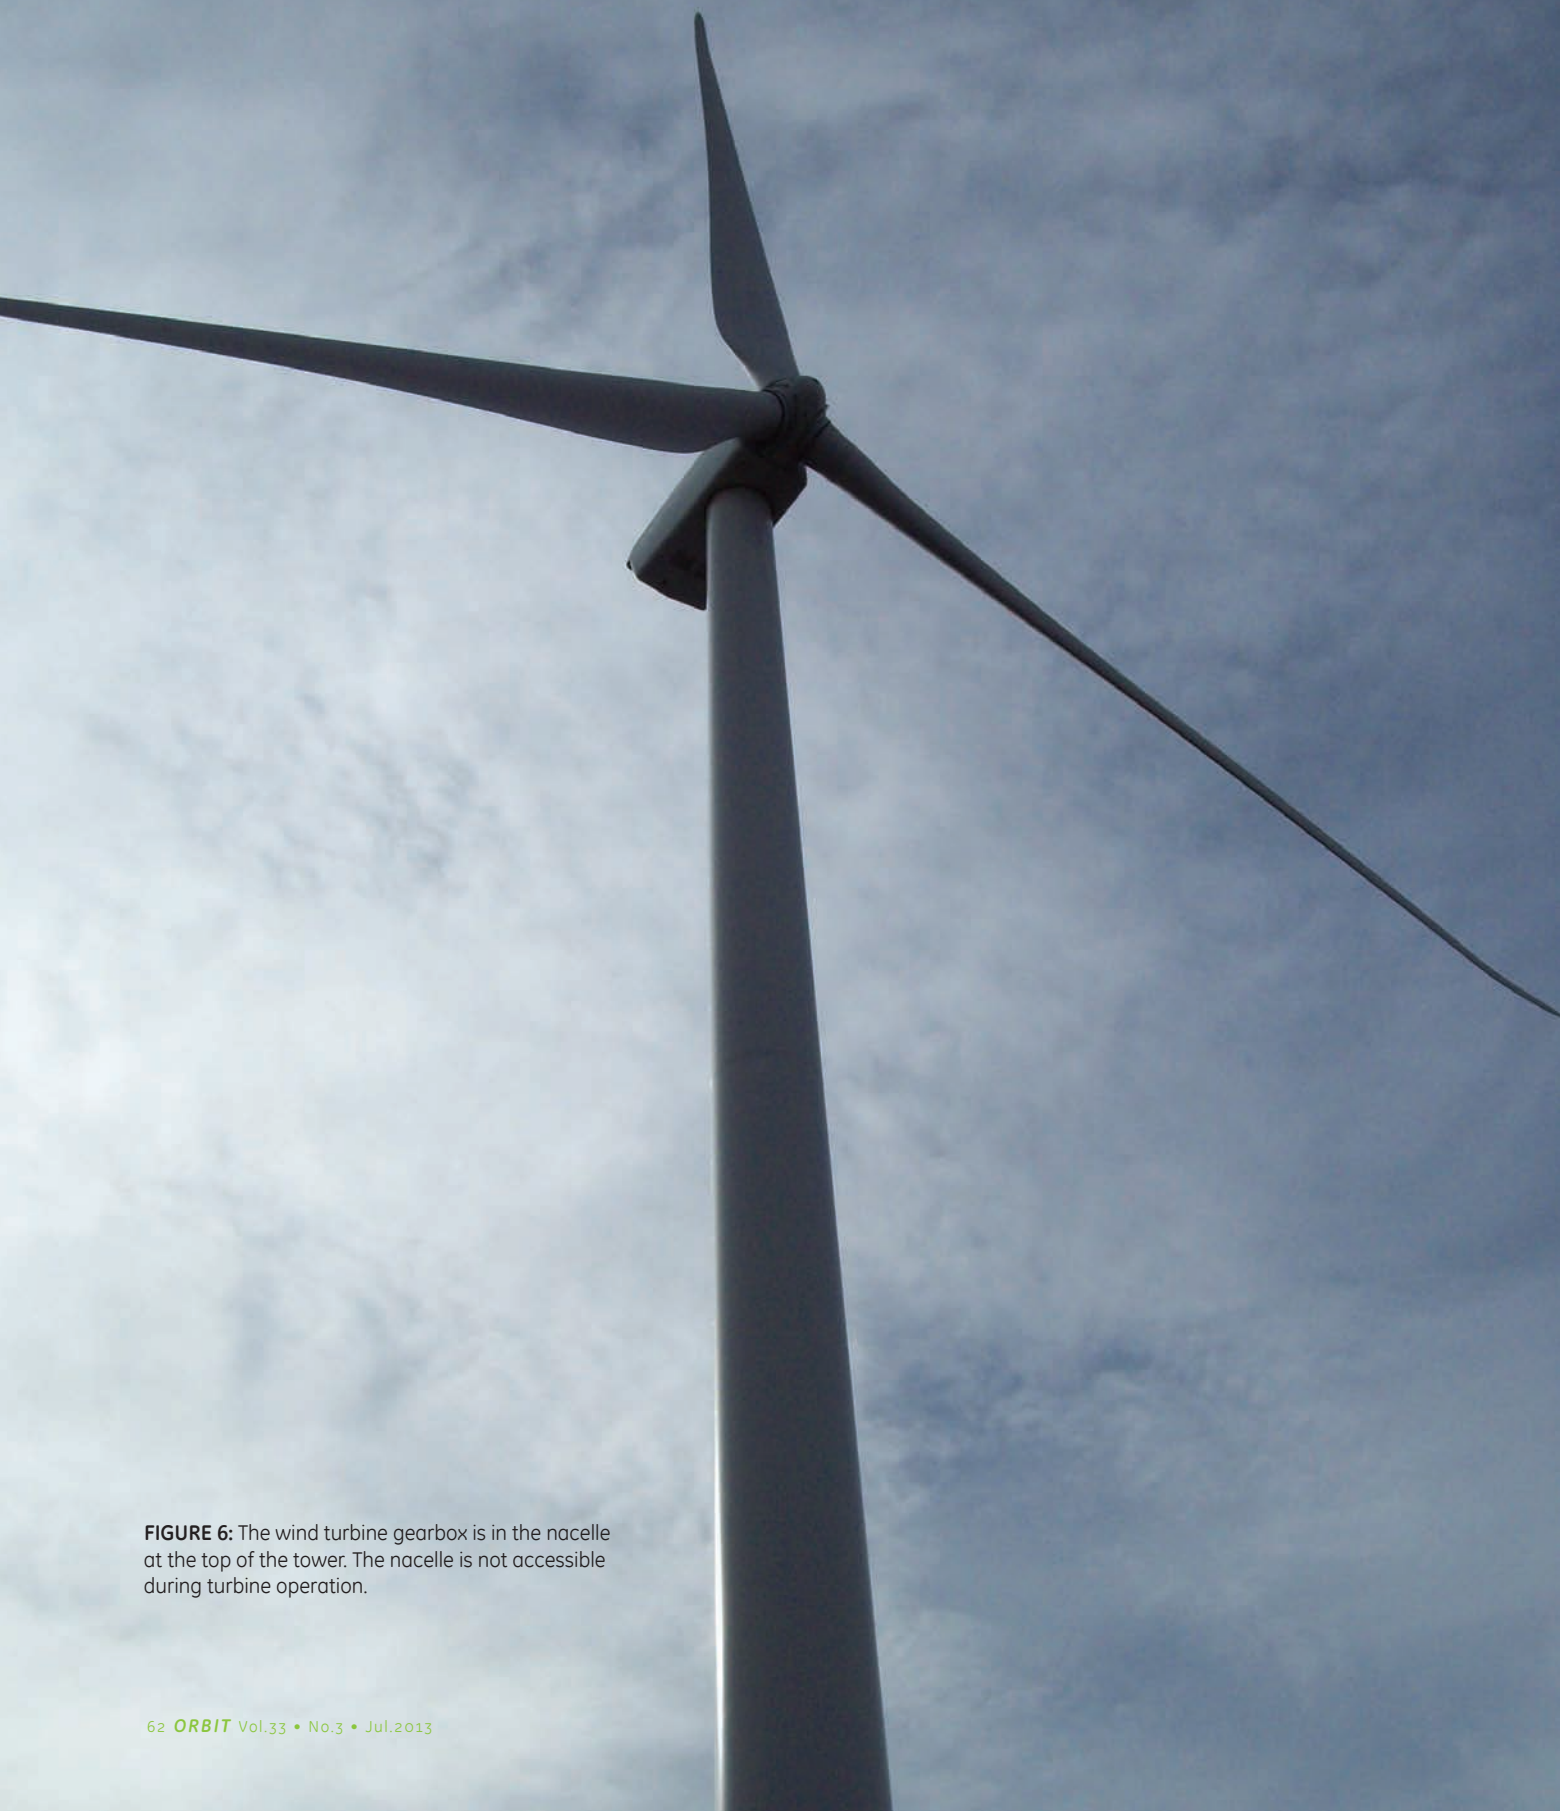
FIGURE 6: The wind turbine gearbox is in the nacelle at the top of the tower. The nacelle is not accessible during turbine operation.

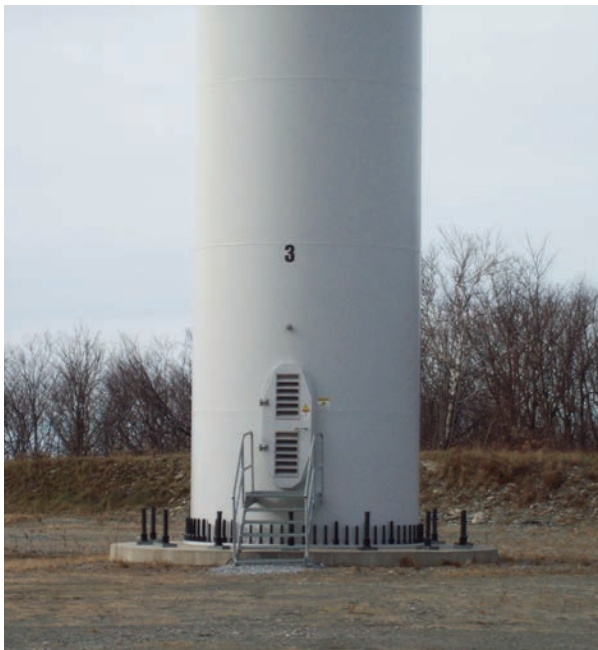
FIGURE 8: The down-tower computer (my laptop) was temporarily set up in the tower base.
