orbit

VOL. 32 | NO. 4 | OCT 2012

A Technical Publication for
Advancing the Practice of
Operating Asset Condition
Monitoring, Diagnostics, and
Performance Optimization

- 16 Designing and Machining
a Keyphasor* Trigger
- 24 System 1* Software Identifies
Rotor Instability

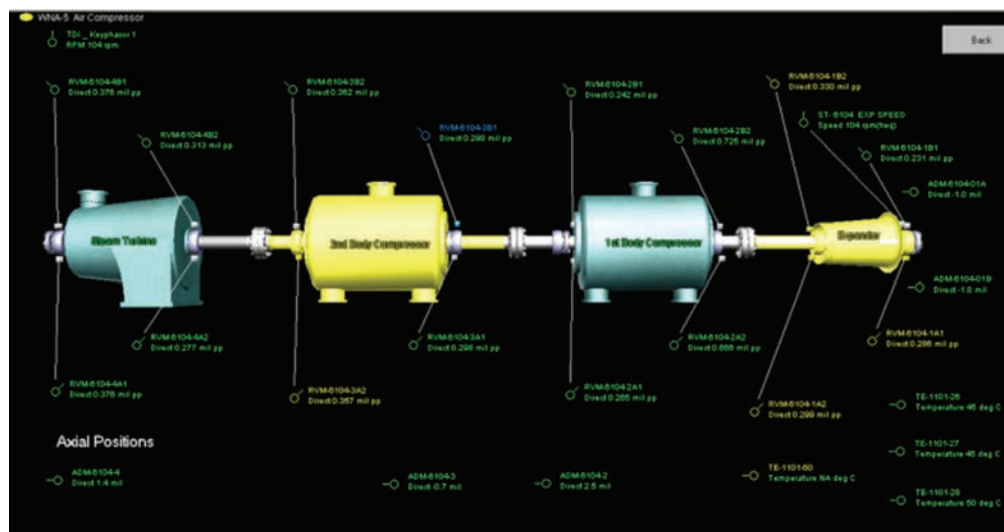
The air compressor described in this article had been installed for more than 25 years at the time of its overhaul. The machine train includes a steam turbine, two separate centrifugal air compressors, and a turbo-expander (Figure 1). The expander reduces the required steam turbine power output during times when reactor off-gas is available to provide power via the expander.

FIGURE 1: System 1 Machine Train Diagram for the air compressor. From left to right are the Steam Turbine, Second Body Compressor, First Body Compressor, and Expander. Current values for monitored parameters are shown in the text blocks.

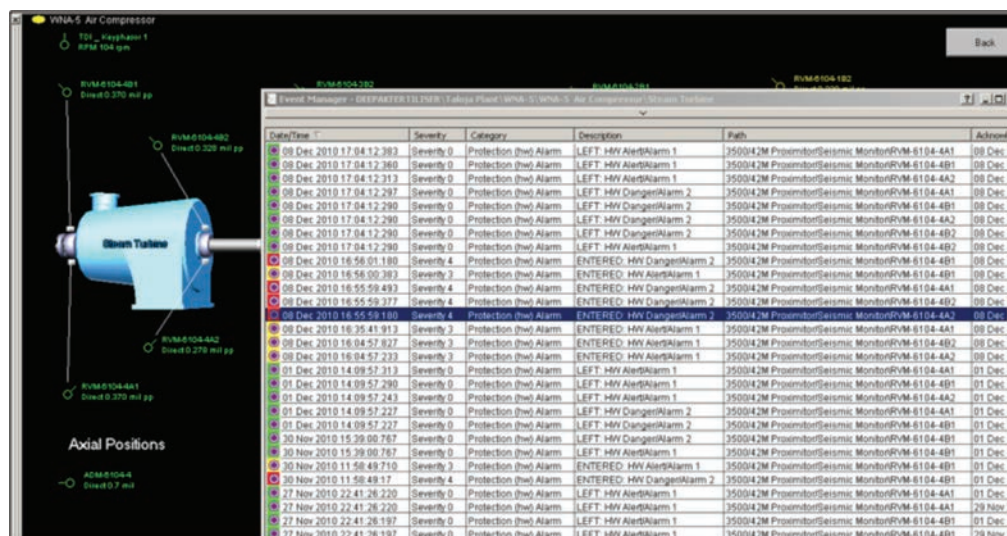
The System 1 Event Manager (Figure 2) showed that the steam turbine tripped on high vibration amplitude at the DE Bearing. However, further investigation revealed that the vibration actually began to increase almost one hour before the trip finally occurred.

FIGURE 2: System 1 Event Manager showing steam turbine trip at 16:55:59:180 Hours on December 8, 2010.

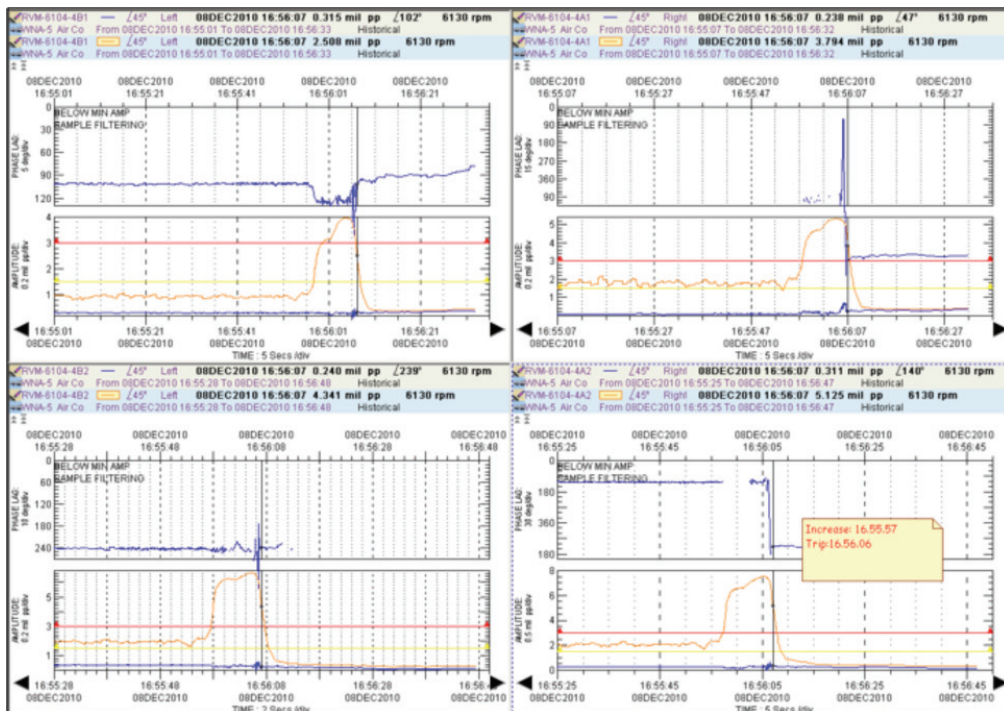
When observing the data that was collected around the time of the trip (Figure 4), it appears that the vibration amplitudes exceeded the "Danger" (automatic trip) setpoint at about 16:55:57 hours, but that vibration then continued to increase for about 9 more seconds (to about 16:56:06), before finally falling below the Danger setpoint at about 16:56:08.

This scenario may lead us to believe that, after the vibration amplitude exceeded the Danger setpoint, there was an unusual delay with the trip relay that prevented a reduction in vibration until after 16:56:06. However, the actual trip delay was verified to be only 3 seconds, which is normal. What the data really shows is a somewhat unexpected instance of vibration continuing to increase for a few seconds after the turbine trip.

FIGURE 4: Plots have been rescaled to look very closely at the time just before and after the steam turbine trip.

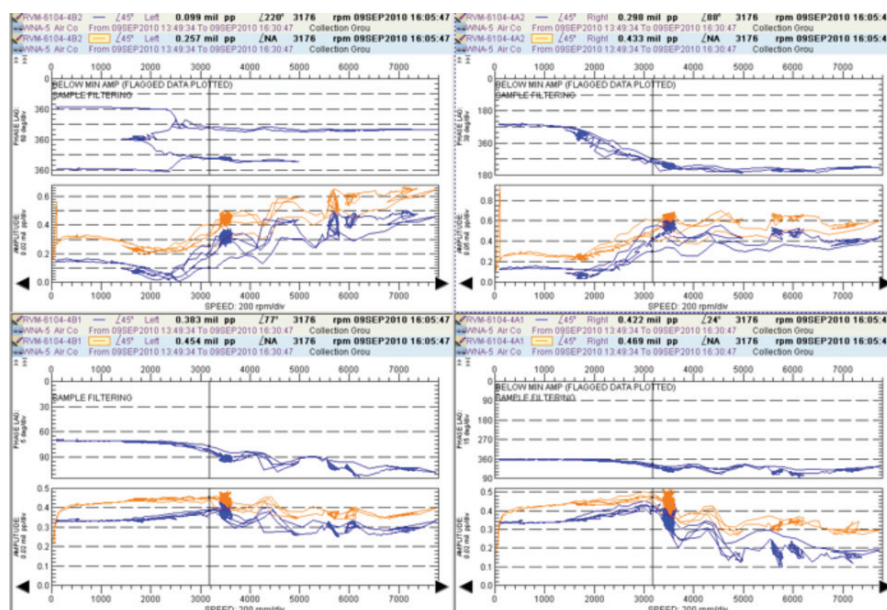
FIGURE 17: Turbine solo run from routine overspeed test of 09SEP2010, showing small amplitudes of vibration.

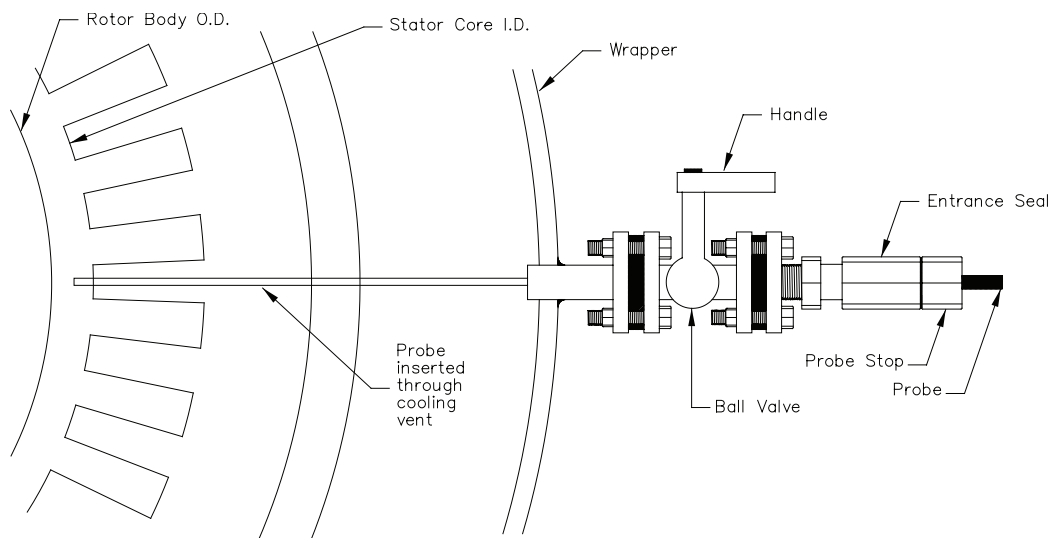
FIGURE 4: This simplified drawing illustrates a temporary air-gap flux probe test setup. It is often possible to install such a probe through an existing access port that allows access to the air gap through a cooling vent in the stator core. For simplicity, this drawing does not show the conductors installed in the stator slots. *Image copyright © 2012 Generatortech, Inc. All rights reserved. Used with permission.*

This method can be used to detect shorted turns, as it is sensitive to rate-of-change of radial flux in the air gap. As each rotor slot passes the flux probe, the slot leakage flux from that slot is detected. Rotor slot leakage flux refers to flux that does not cross the air gap to reach the stator winding. Since the leakage flux does not include stator current, the leakage flux does not contribute to power generation (Reference 4). As shown in Figure 4, the flux probe can be installed

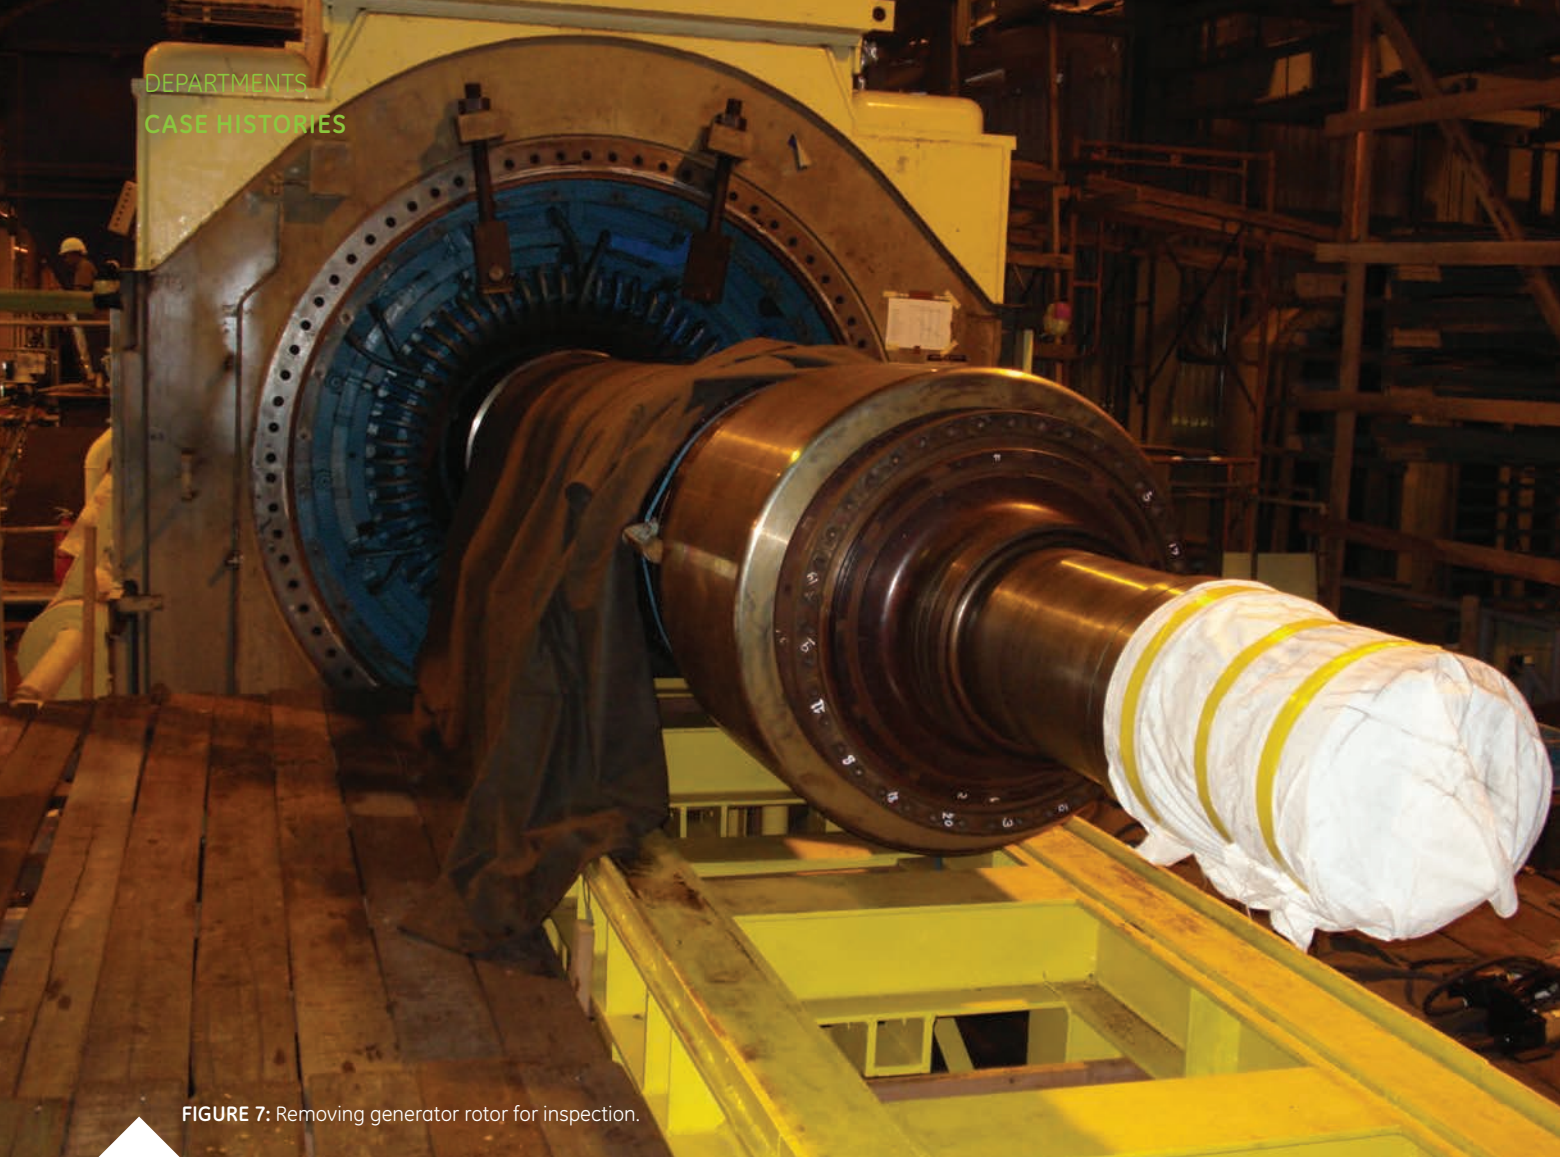
The inspection confirmed the presence of failed insulation leading to the already suspected shorted-turn problem at coils #2 and #3. At these short circuited locations, electrical resistance is relatively low, resulting in low rotor temperature whereas on the opposite side of the rotor, where resistance is normal, the temperature is somewhat higher. The rotor tends to expand on the higher temperature side causing the rotor to thermally bow and subsequently causing synchronous vibration to increase (Reference 1).

FIGURE 7: Removing generator rotor for inspection.

Since available time during the hot gas path inspection was very limited, a full generator rotor rewind repair could not be carried out, requiring instead a partial rewind repair of the rotor. Following the partial repair, the
